| <b>Curtins Consulting Ltd</b><br><br>K Village, Riverside Place, Units<br>24-25, Lound Rd, Kendal LA9 7FH | <b>Subject</b><br><br>Cleator Moor Innovation Quarter<br>Photograph Survey Log | | <br><br>Sheet No: 01 |
| | <b>Job No:</b><br><b>085788</b> | <b>Made by:</b> JTS<br><b>Chkd by:</b> PT | |

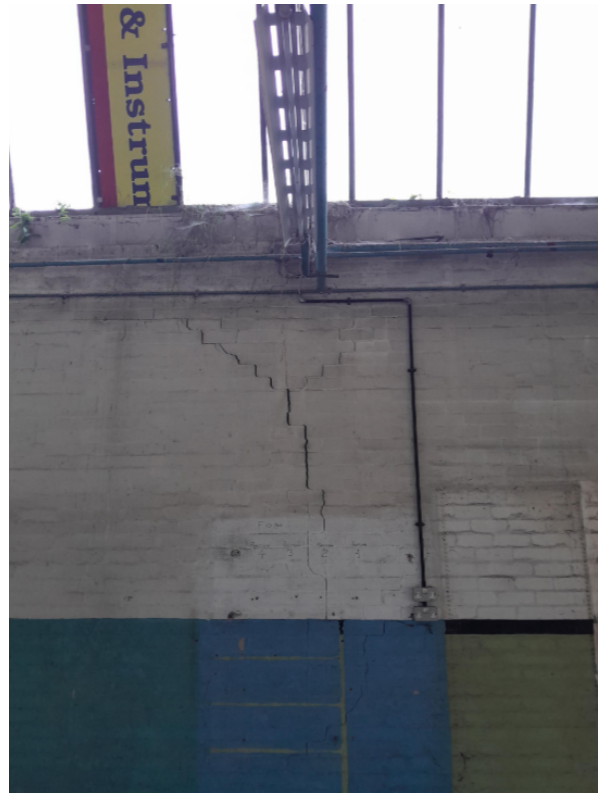
Figure 69 - existing buildings to be demolished **to be demolished**

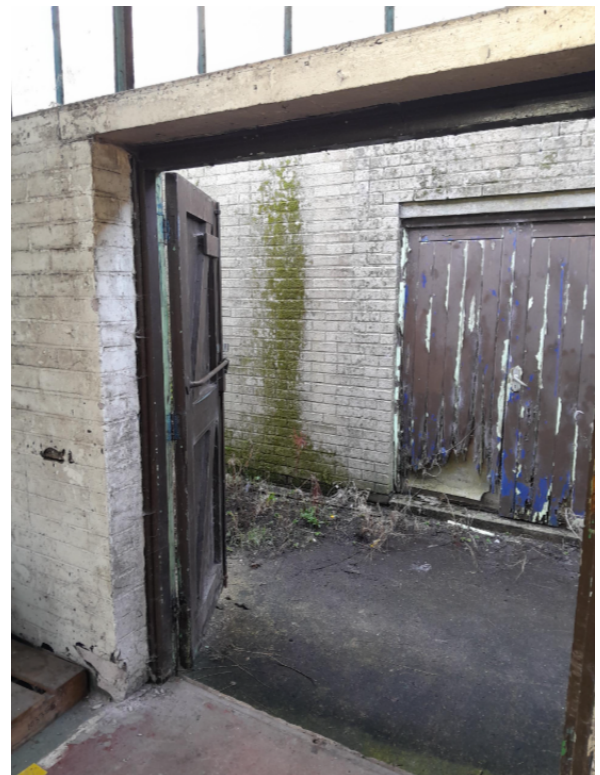
Figure 70 - existing buildings **to be demolished**

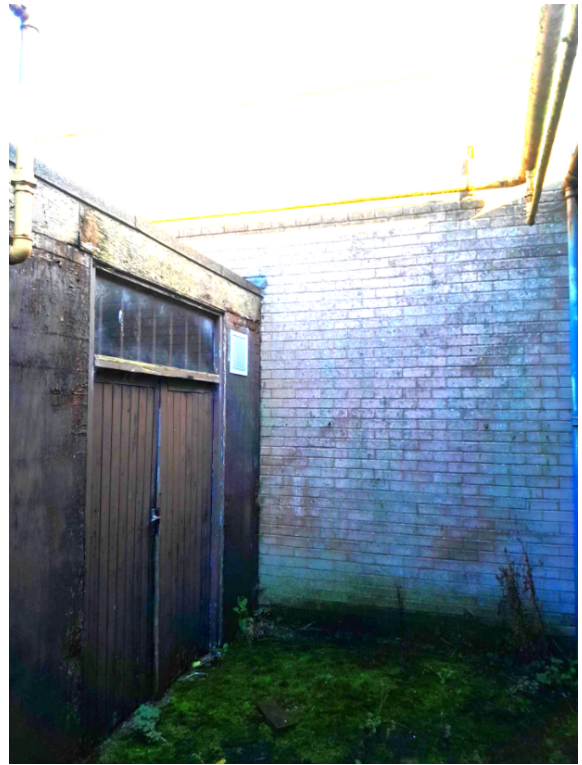
Figure 71 - existing buildings to be demolished **to be demolished**

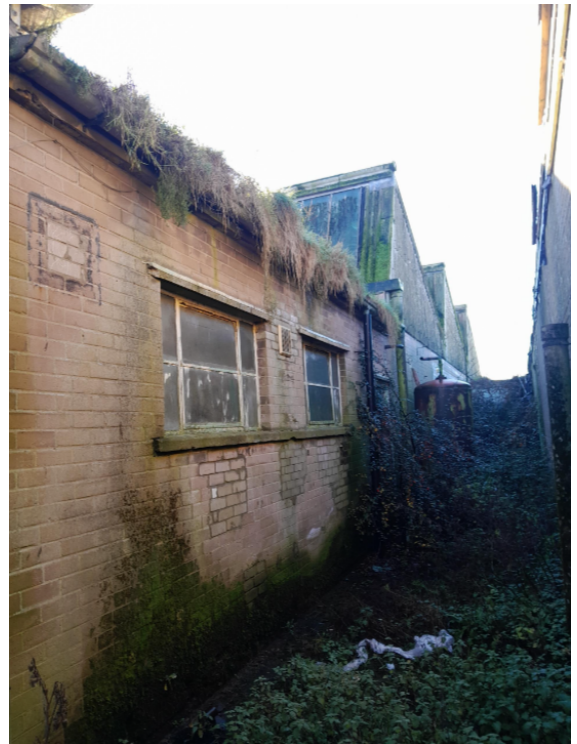
Figure 72 - existing buildings **to be demolished**

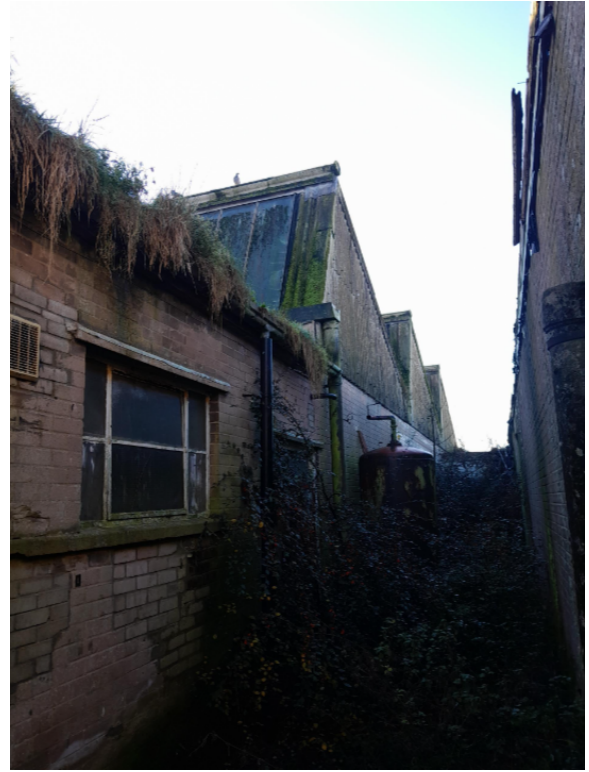
Figure 73 - existing buildings to be demolished **to be demolished**

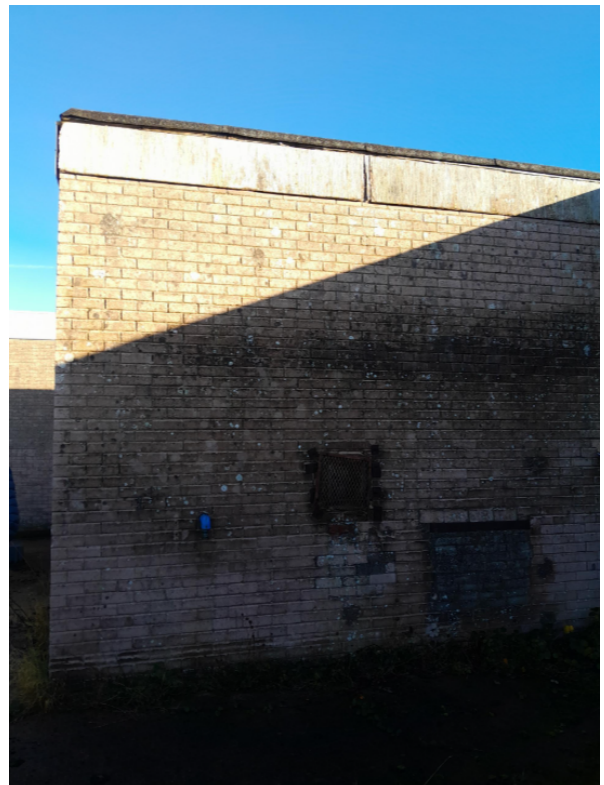
Figure 74 - existing buildings **to be demolished**

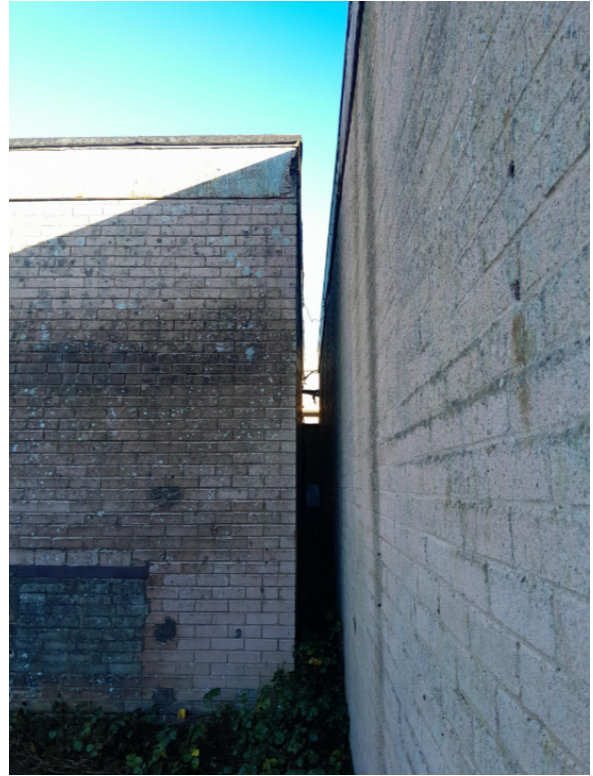
Figure 75 - existing buildings to be demolished **to be demolished**

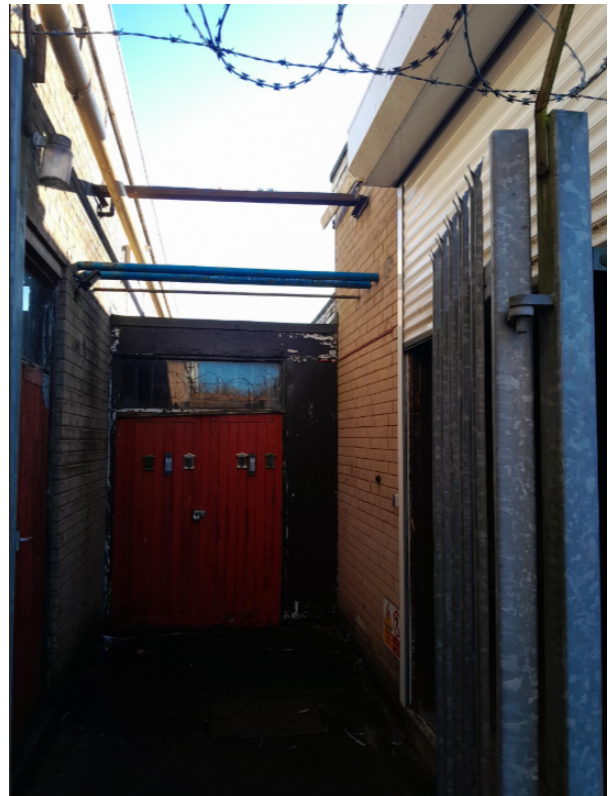
Figure 76 - existing buildings **to be demolished**

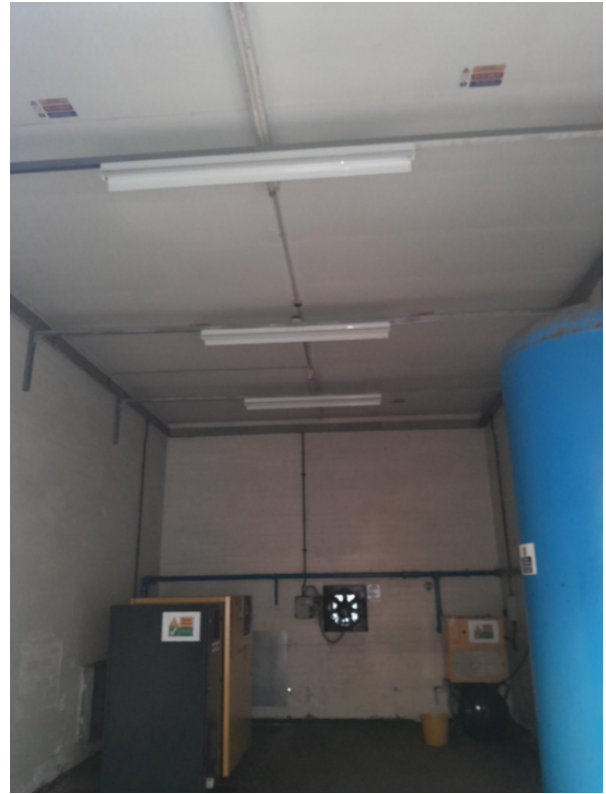
Figure 77 - existing buildings to be demolished **to be demolished**

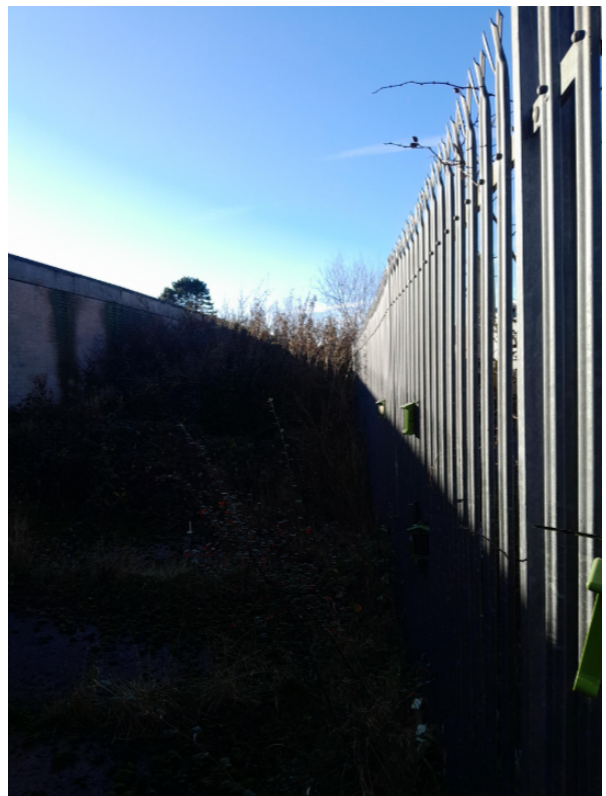
Figure 78 - existing buildings **to be demolished**

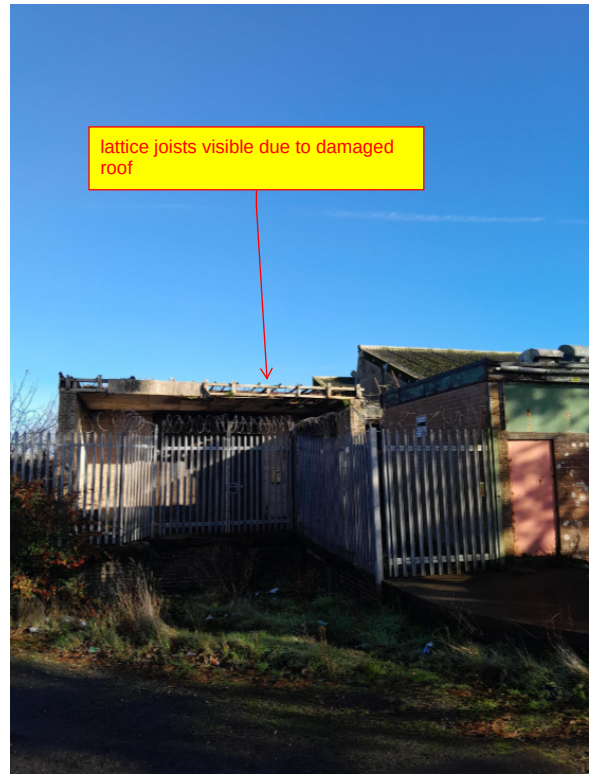
Figure 79 - existing buildings to be demolished

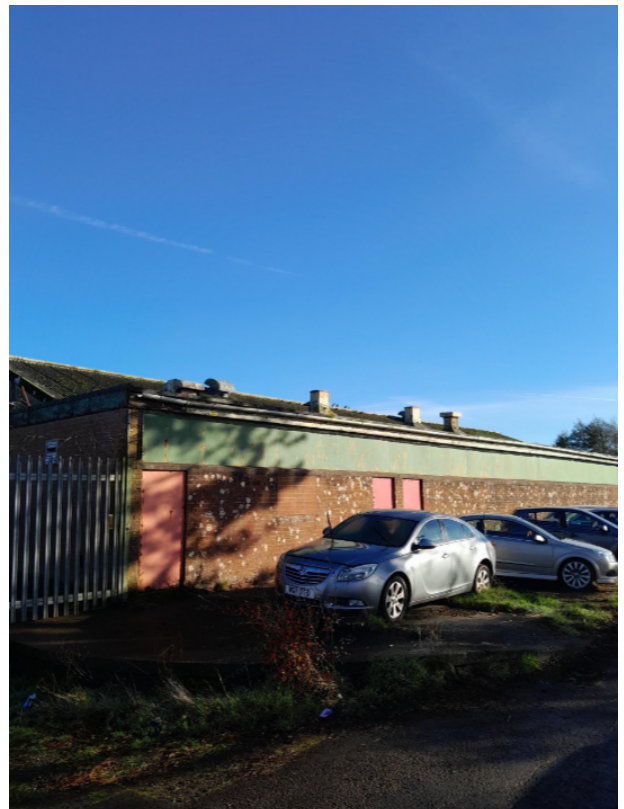
Figure 80 - existing buildings to be demolished

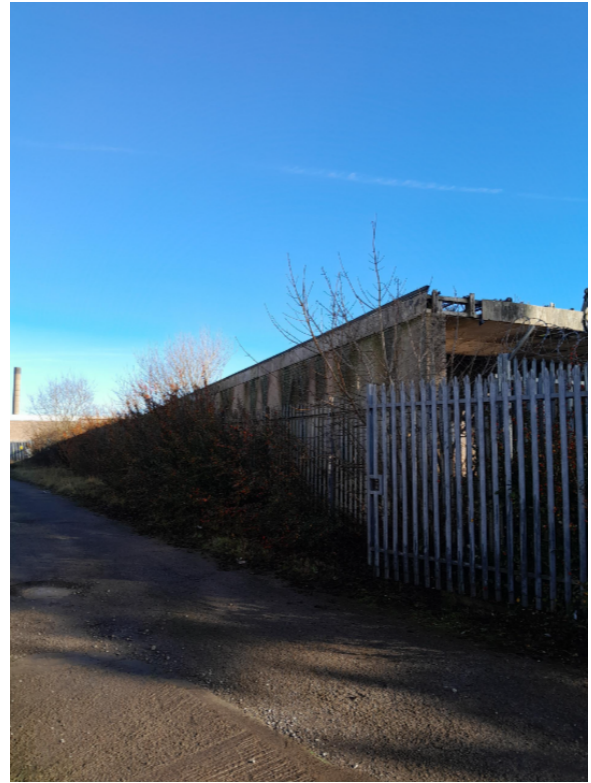
Figure 81 - existing buildings to be demolished

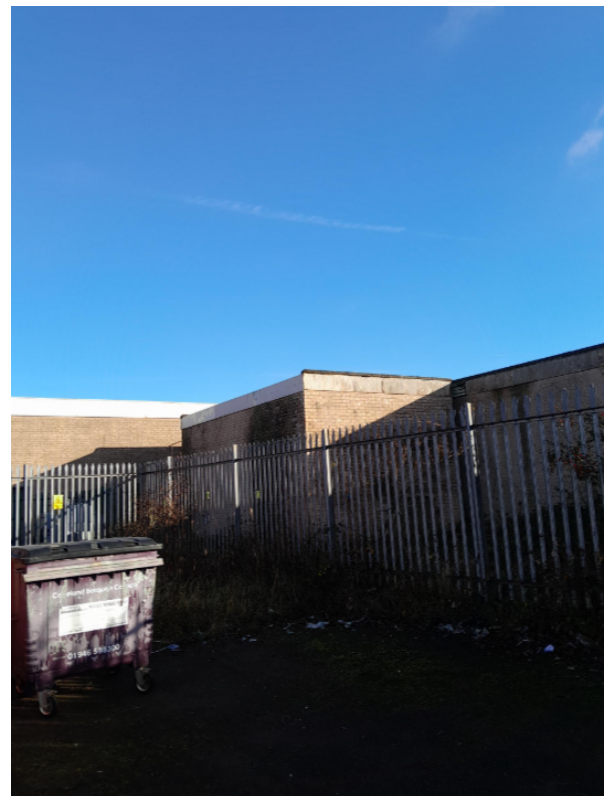
Figure 82 - existing buildings to be demolished
